HAZARD ALERT

WORKER FATALLY INJURED IN ROCK CRUSHER EXPLOSION

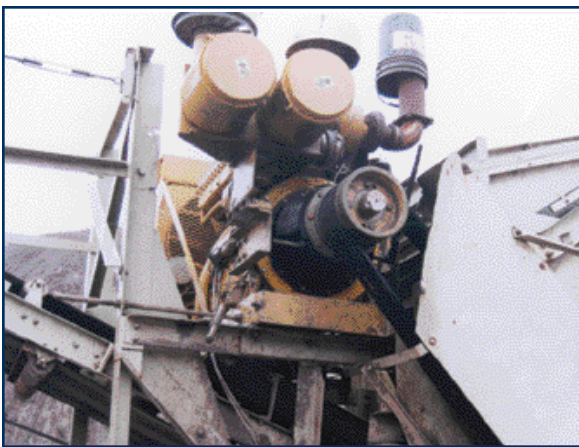
Shortly after starting up the rock crusher for a day's production, smoke was seen coming from the transmission housing. The operator immediately went to disengage the clutch and look for the source of the smoke. At that instant, the transmission blew apart with the debris causing a fatal wound. One 200 lb. piece flew 18 feet, striking a payloader.

The WHSCC investigation determined that the crusher had been properly lubricated, with operational repairs made as required. Maintenance records were not documented, nor was there a maintenance schedule.

The drive assembly typically may require 12 to 18 belts on the drive spool. For this, the supplier recommends that there be belts for each position. Operators typically wait until it is necessary to replace an entire set of belts. When this takes place, to compensate for having fewer drive belts, operators must increase the tension on the remaining belts. This results in a condition known as "side loading". This condition increases the load on the clutch assembly, potentially causing the seal to leak and create excessive wear on the clutch, leading to overheating. Should the bearing lose lubrication fully, the result is an explosive disintegration of the transmission.

1. Schedule maintenance (such as all lubrication and bearing inspections), track hours of operation, and above all document all the work that is done (lubrication by type and location, repairs made, alterations, etc.).
2. Apply the proper tension to the drive belts as per manufacturer's specifications.
3. Match the capacity of the drive unit to that of the clutch assembly.
4. Follow all supplier recommended preventive maintenance schedules.
5. Do not exceed manufacturer's recommended limits for side-pull loading.
